AEFA PROJECT NO. 84-23

# ARTIFICIAL AND NATURAL ICING TESTS OF AH-64 (PHASE II)

MARCH 1987

FINAL REPORT

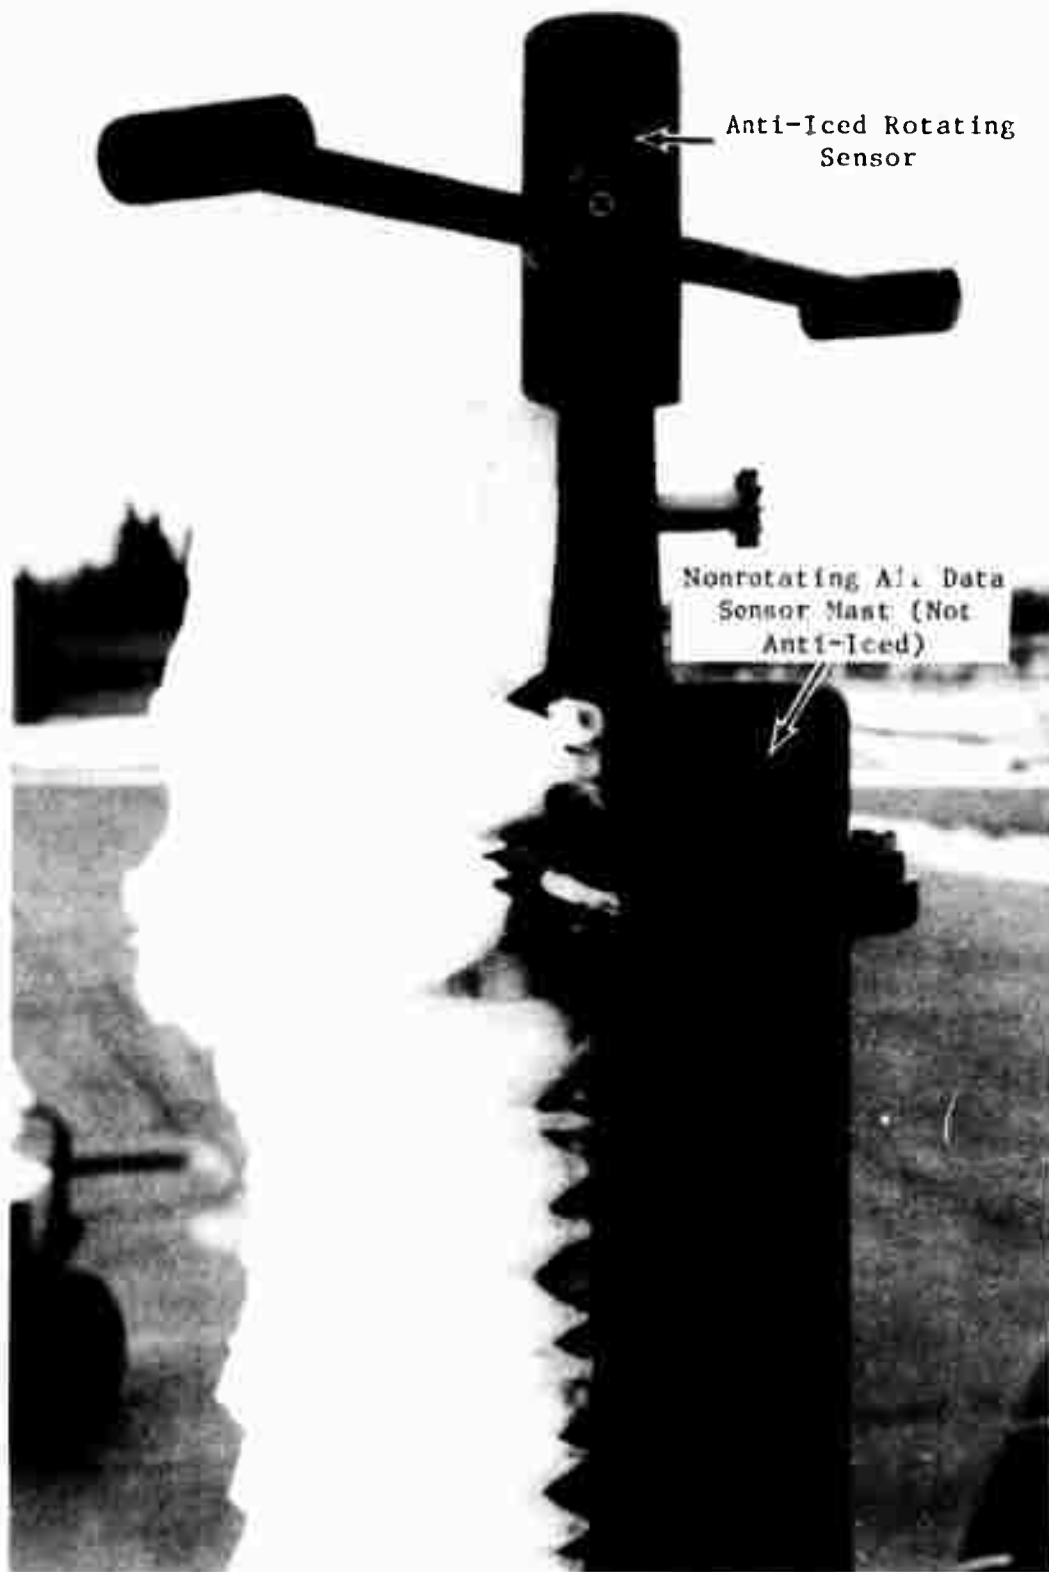
Photo 3. AH-64A - Air Data Sensor

22. The Air Data Sensor (ADS) was located above the main rotor and attached to a stand pipe through the main rotor mast. The rotating hub and arms of the ADS were electrically heated. The same switch that activated pitot heat activated the ADS anti-ice system. Ice did not accrete on the heated portion of the ADS (photo 3). On one occasion after departing icing conditions, an ADS failure occurred probably due to a weak heater. The ADS was replaced and no further incidences occurred. The ADS anti-ice system is satisfactory.

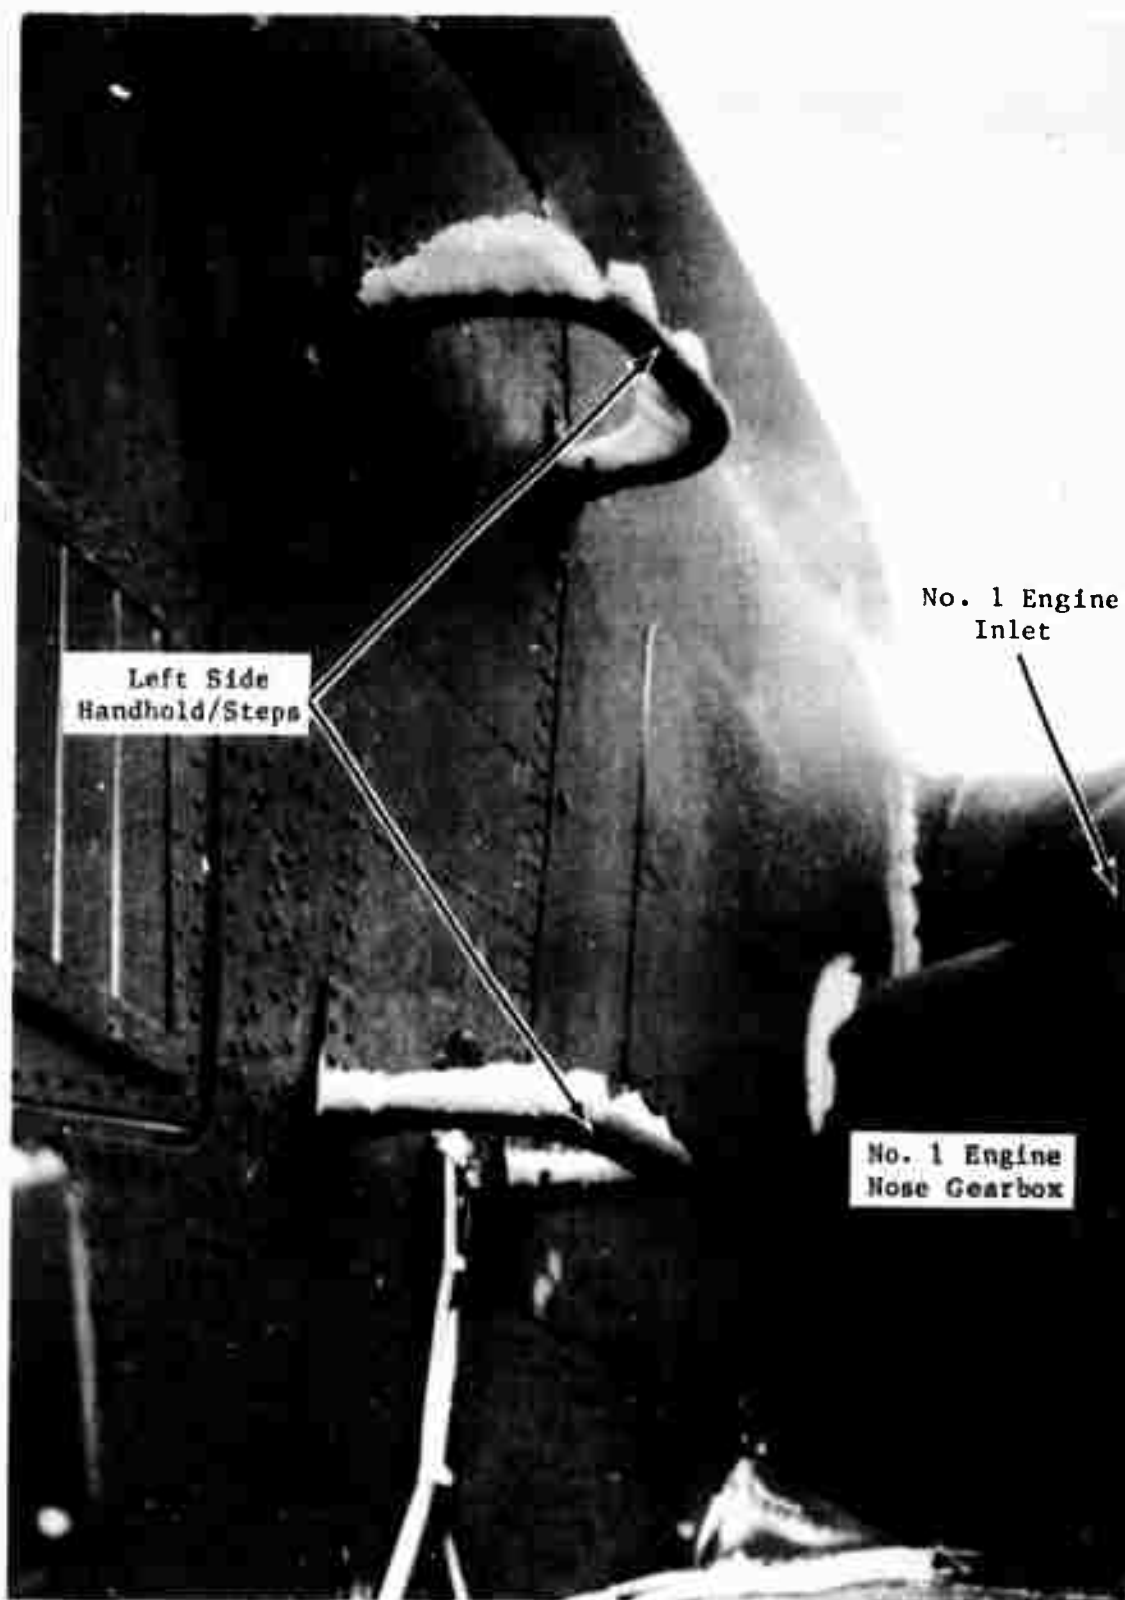
Photo 4. AH-64A - Left Side Fuselage

27. Typical fuselage ice accretions are shown in photo 4, enclosure 6 to appendix F. Large accumulations of ice were noted on the wing leading edges, nose, handholds/steps, landing gear, landing gear struts, and surface irregularities on the fuselage but created no operating difficulties. All windows, doors, and access panels remained functional after icing encounters. Ice accretion and shedding from the right and left side fuselage handholds/steps (photo 4) create the potential for engine FOD (see para 31) but no damage was specifically documented as being due to ice shed from these areas. Future aircraft designs should incorporate recessed handholds/steps to minimize ice accretion and FOD potential.

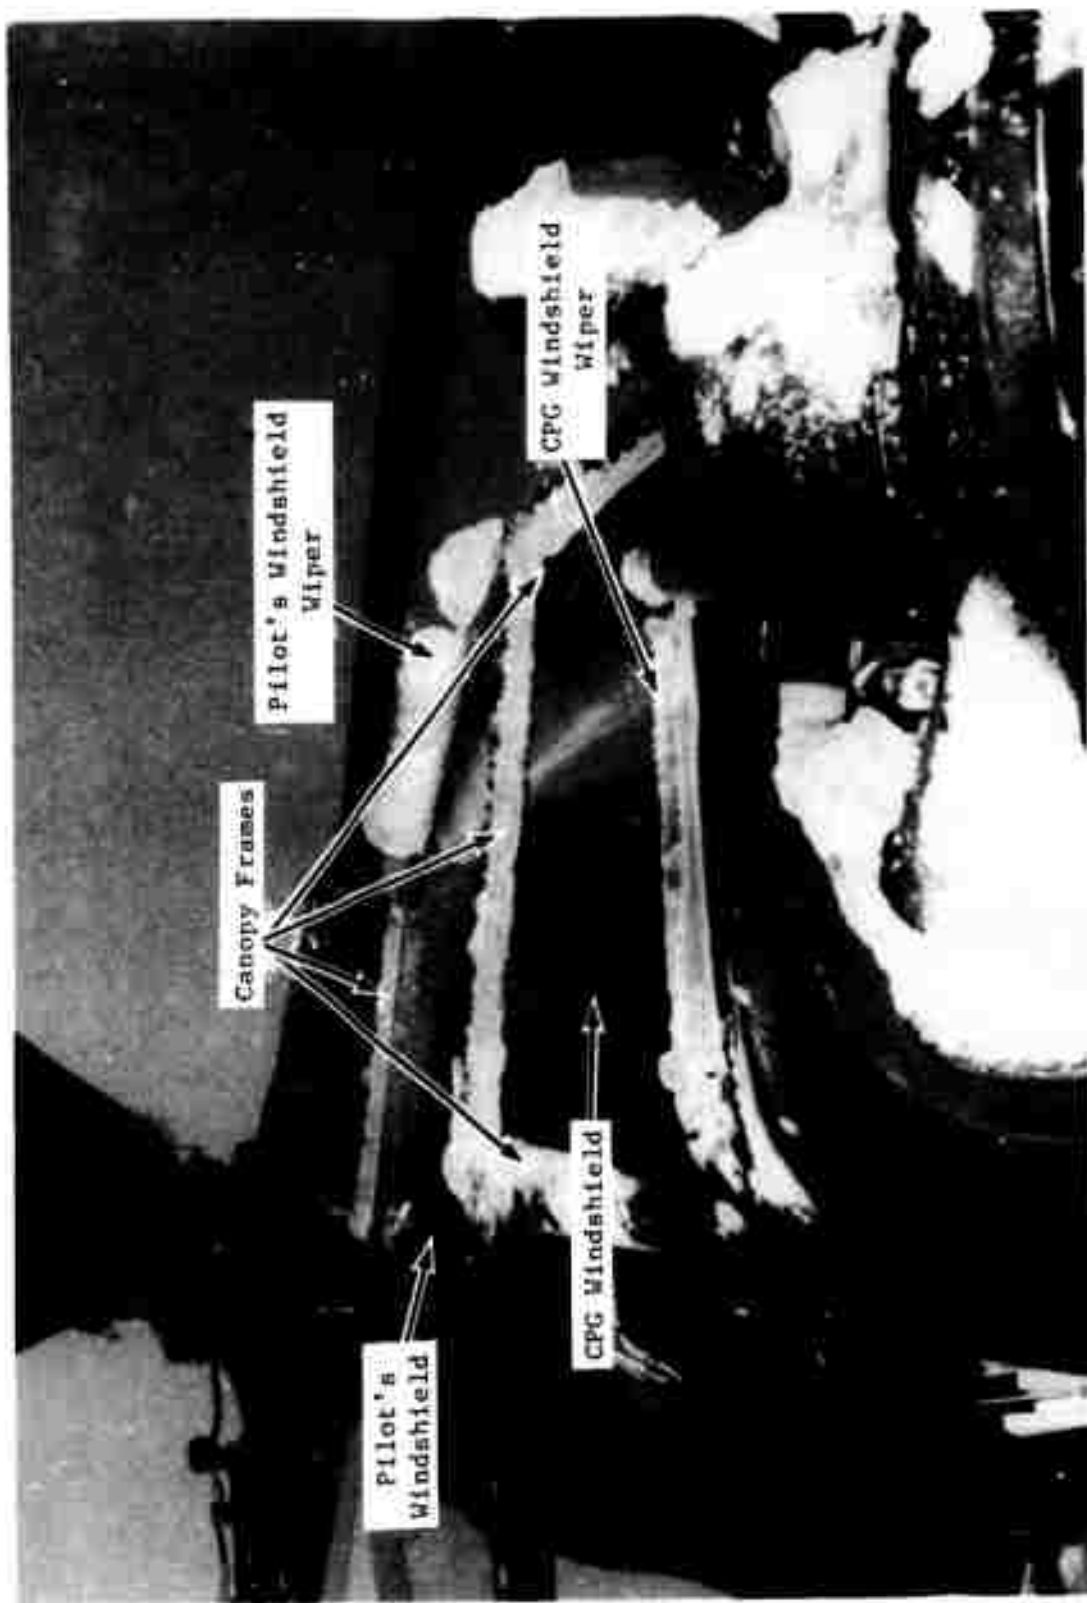
Photo 5. Canopy Frames and Windshield Wipers

29. The framework supporting the essentially flat plate canopy was not anti-iced. The forward canopy frames accreted large quantities of ice (photo 5) which could break away during flight and damage aircraft components or result in engine ice ingestion. No damage was specifically documented as being due to ice shed from the canopy frames. Future aircraft designs should incorporate canopy frames which minimize ice accretions.

30. Large ice formations on both the pilot's and CPG windshield wipers (photo 5) could break away resulting in aircraft damage or engine ice ingestion. No damage was specifically documented due to ice shed from the wipers. The wipers were deliberately not activated in flight to prevent any damage. Future aircraft designs should incorporate windshield wipers which minimize ice accretions.

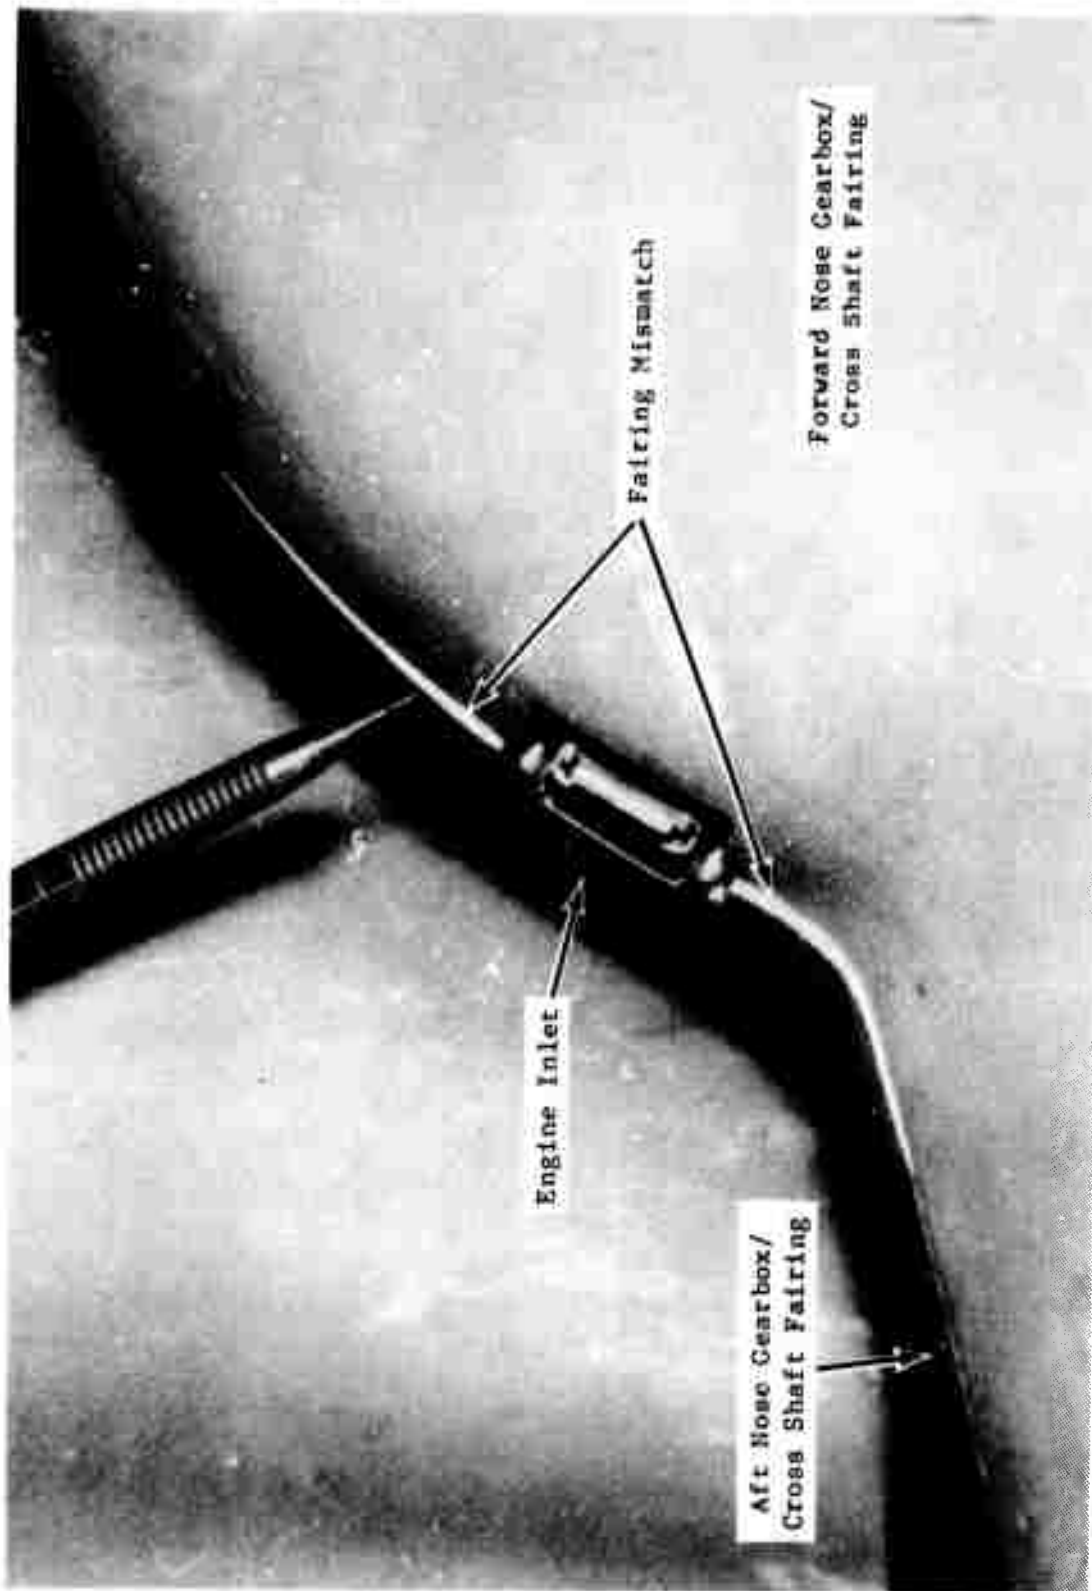
Photo 6. No. 1 Engine Inlet

32. Ice accretion on the mismatch at the joint between the fore and aft nose gearbox/cross shaft fairings was previously documented during artificial icing tests (photo 6, enclosure 6 of appendix F). Ice accreted in this area is immediately in front of the engine inlet and presents a high probability of damage to the engine. No permanent modification to correct this problem has yet been implemented and the mismatch has been observed on most production aircraft. The fairing edges were smoothed during this test to eliminate the mismatch and prevent engine FOD. An example of the mismatch present with the most recent fairing configuration is shown in photo 6. The high potential for engine FOD due to shed ice from the mismatch at the joint between the fore and aft nose gearbox/cross shaft fairing is a deficiency.

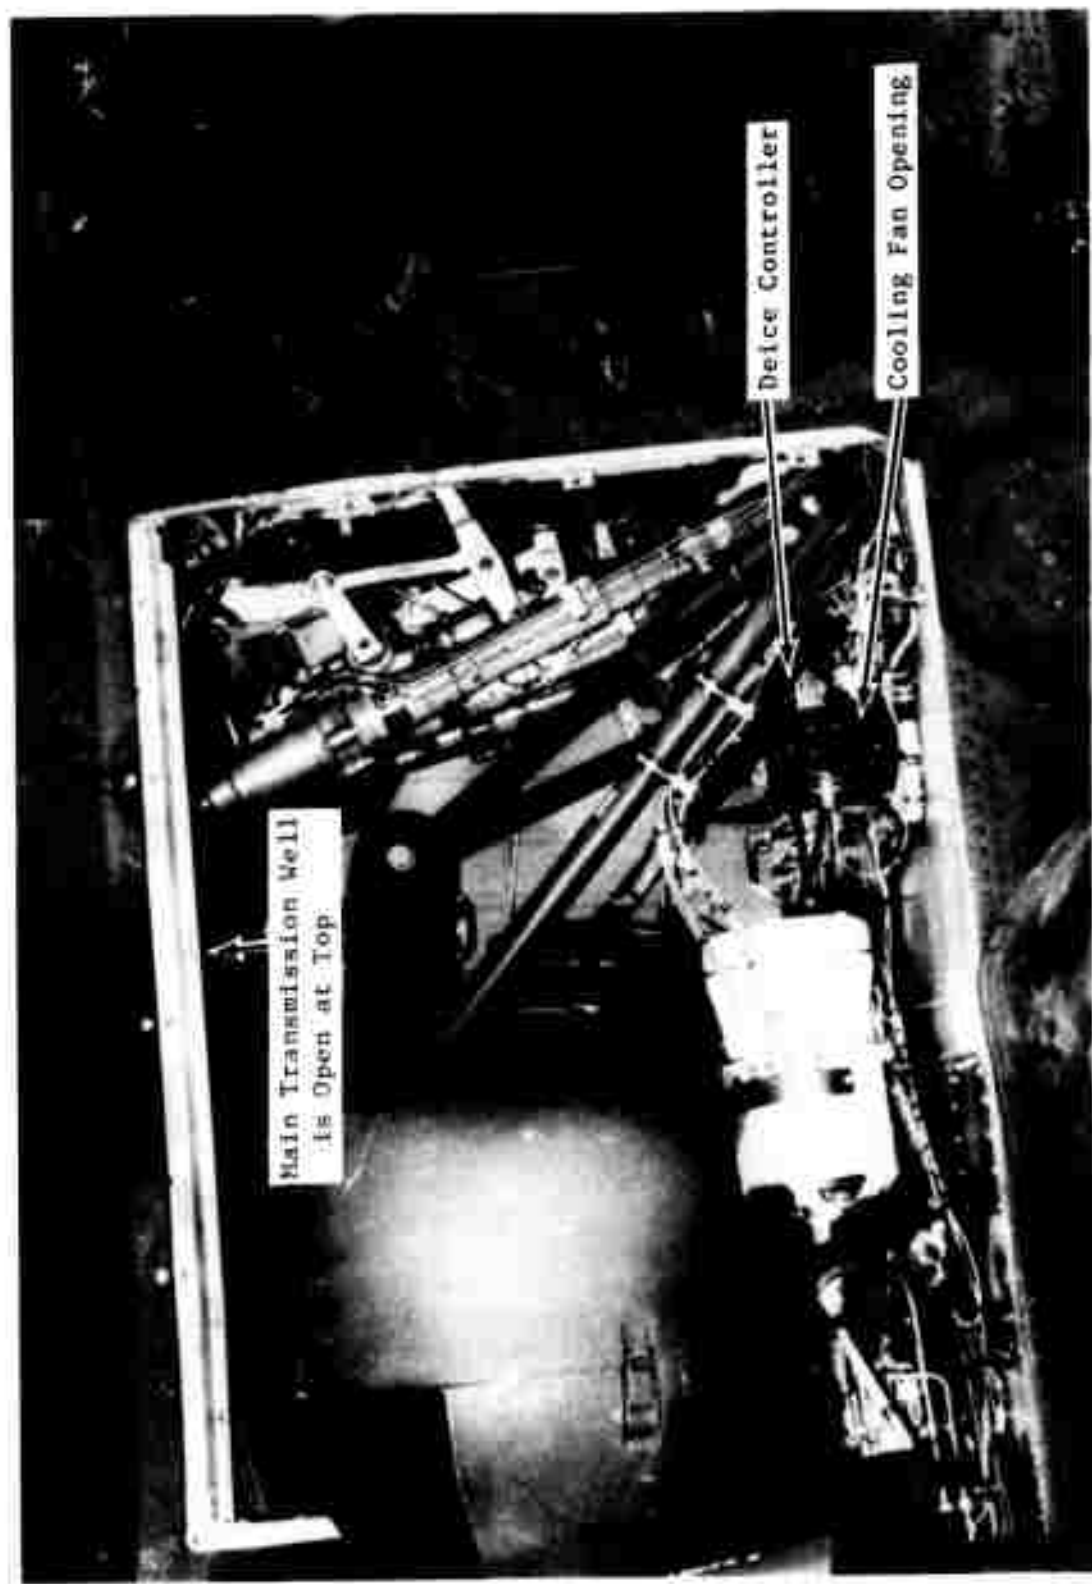
Photo 10. Fuselage Right Side - Main Transmission Access Panel Removed

48. The main and tail rotor deice controller is mounted on the forward transmission deck (photo 10). Cooling vents and a fan

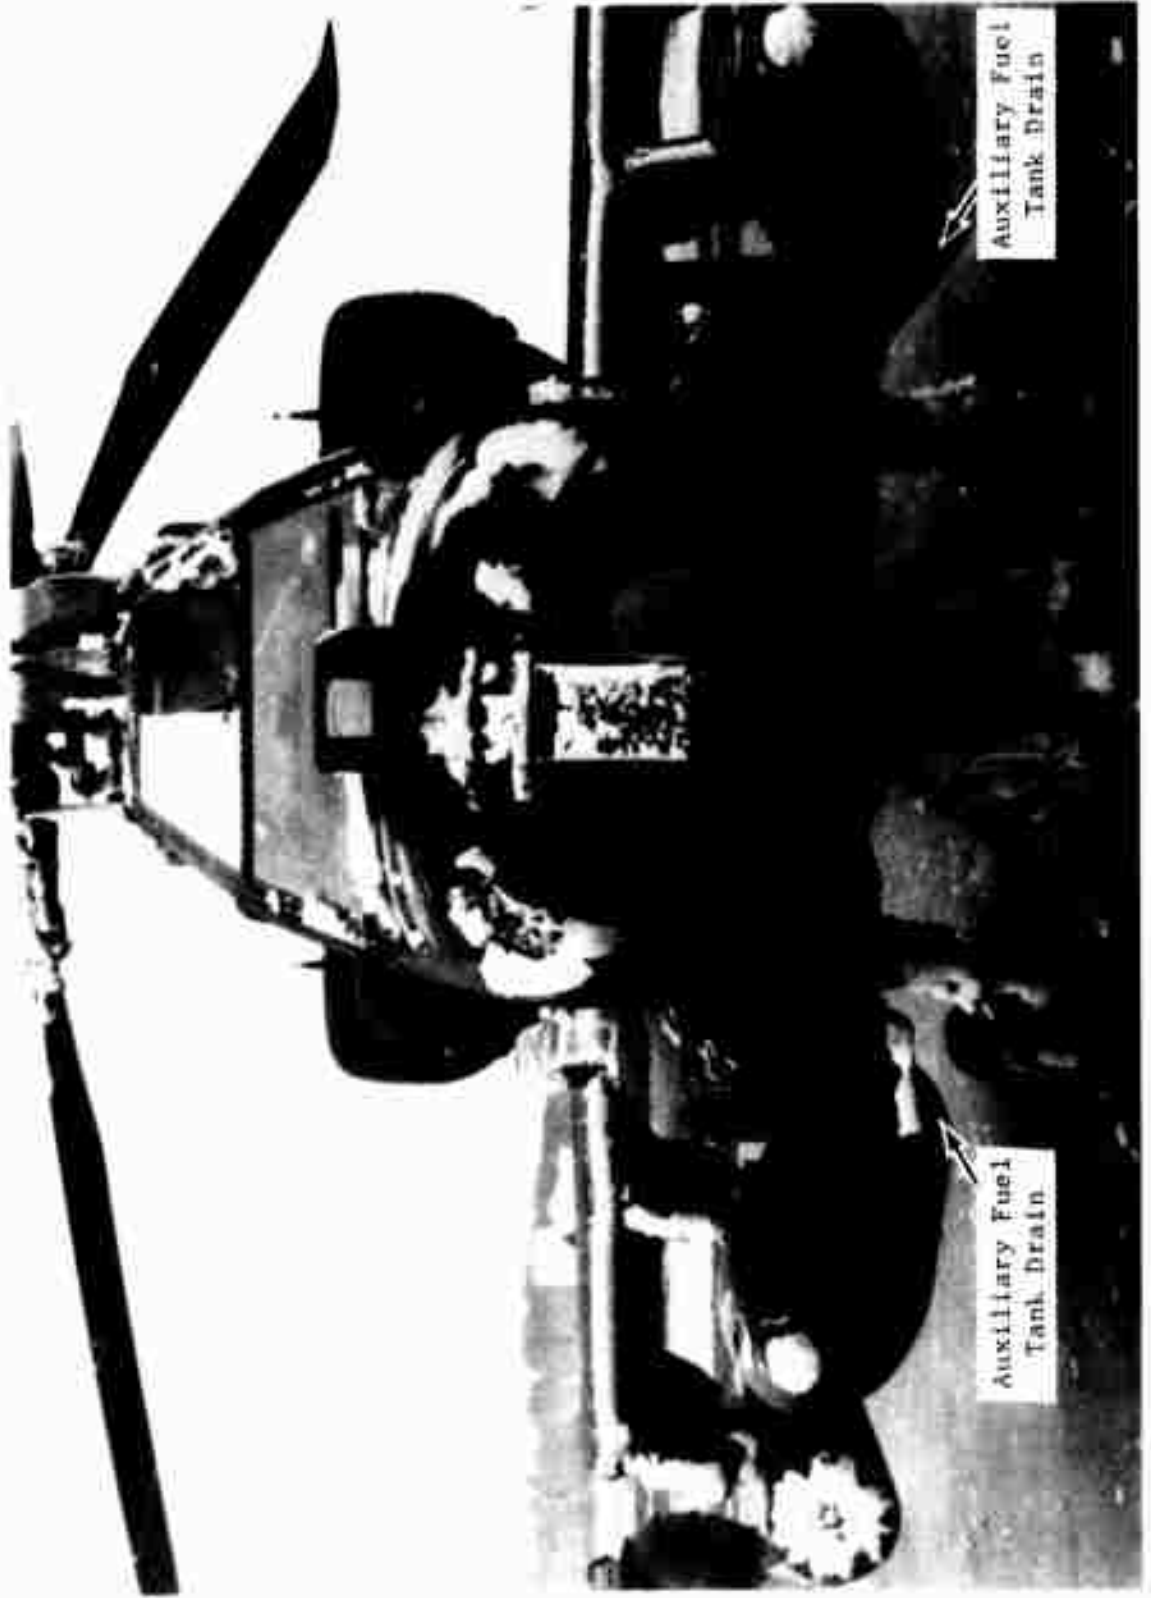
Photo 12. AH-64A - Front View

51. External auxiliary fuel tanks were installed on the test aircraft (photo 12). Fuel was transferred from the external tanks by means of the pressurized air system. When the aircraft is shutdown, the external tanks remain pressurized. When the aircraft was hangared for several days with the tanks pressurized, fuel began leaking from the tank access panels (photo 13) and fuel line fittings. The only way to vent pressure from the external tanks was to open the fuel filler caps following each flight. The tendency of the external auxiliary fuel tanks to

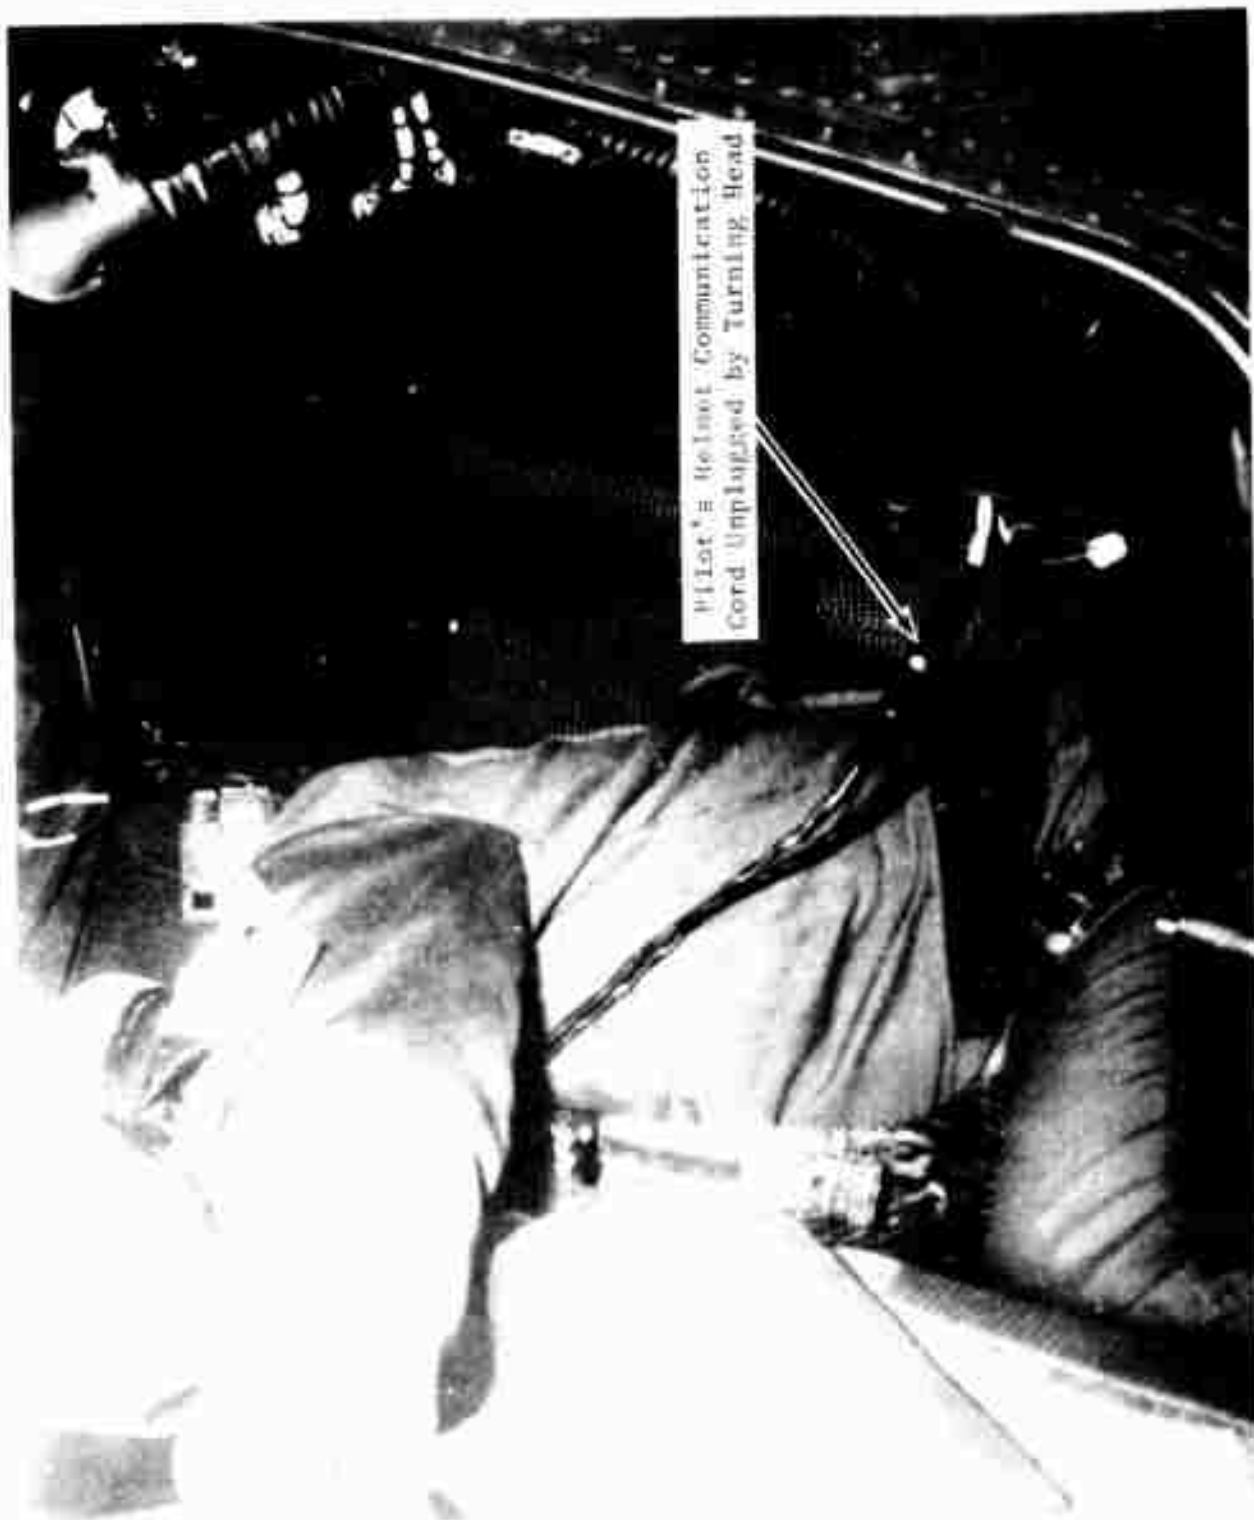
Photo 14. Pilot Station - Left Side View

54. The production configuration position of the aircraft communication cord connector has been modified since the previous evaluation reported in appendix F. During flight, the pilot and CPG inadvertently unplugged their helmet communication cord from the aircraft connector by simply turning their heads to the right or leaning forward to perform normal cockpit duties (photo 14). The integrated helmet and display sight system (IHADSS) cord remained connected. Both the pilot and CPG experienced this loss of communication capability on numerous occasions during instrument flight. The inadvertent unplugging of the helmet communication cord is a shortcoming.

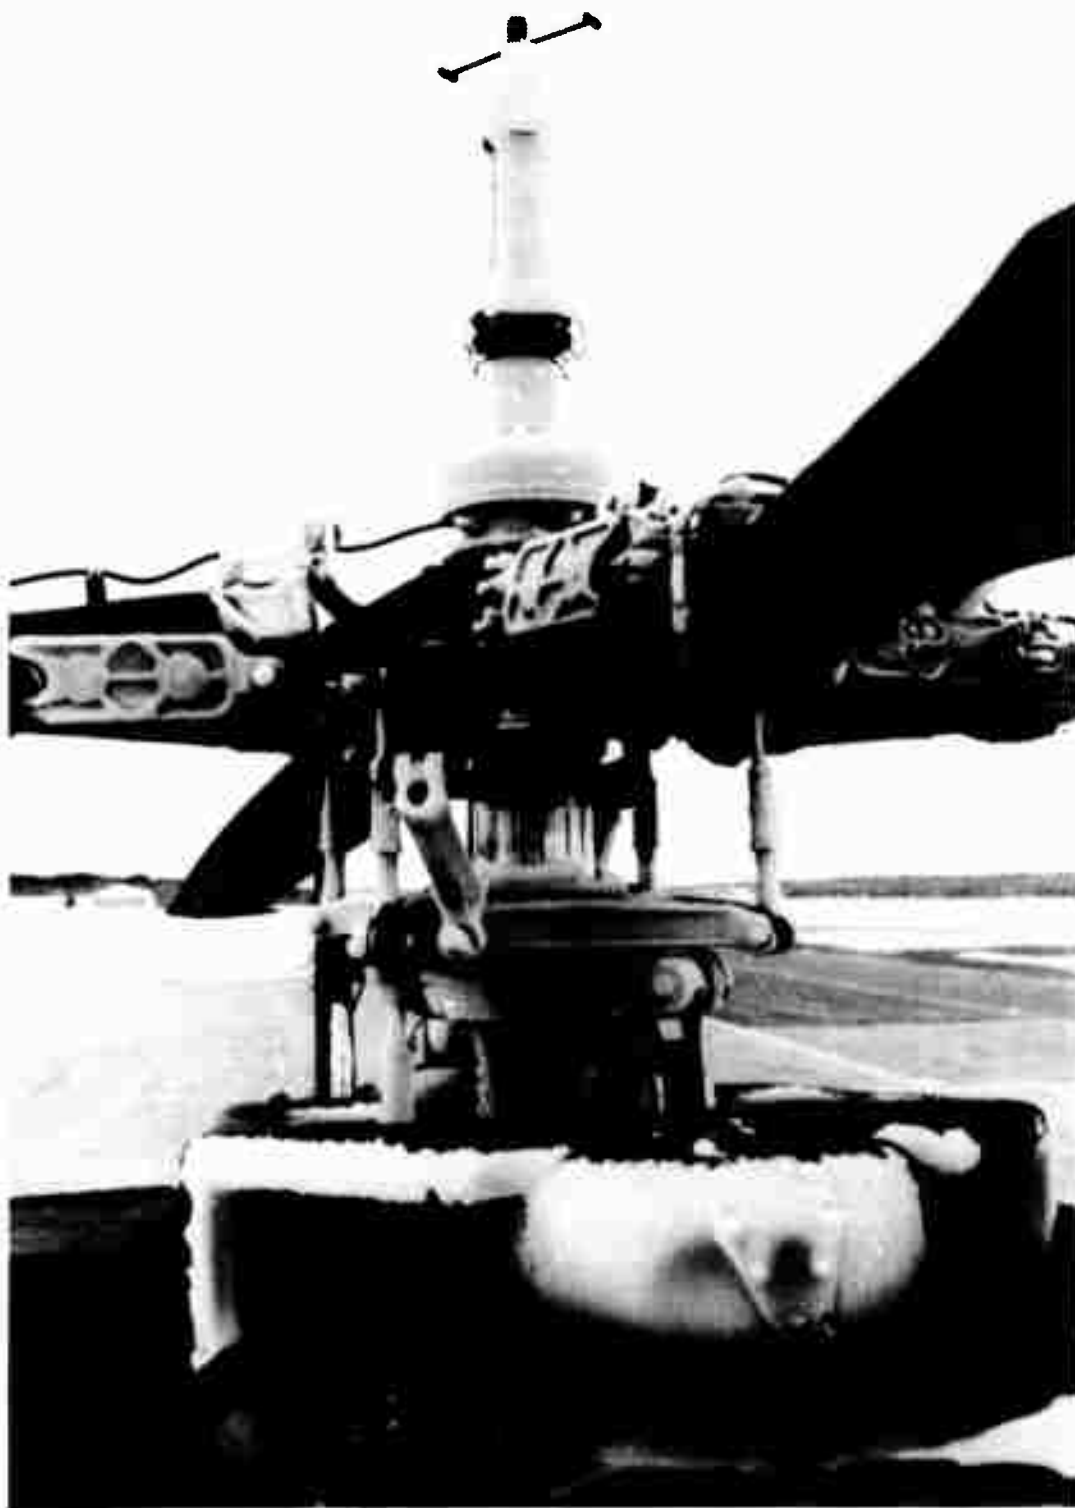
Photo 2. Residual Ice Accumulation on Unprotected Main Rotor Head Components

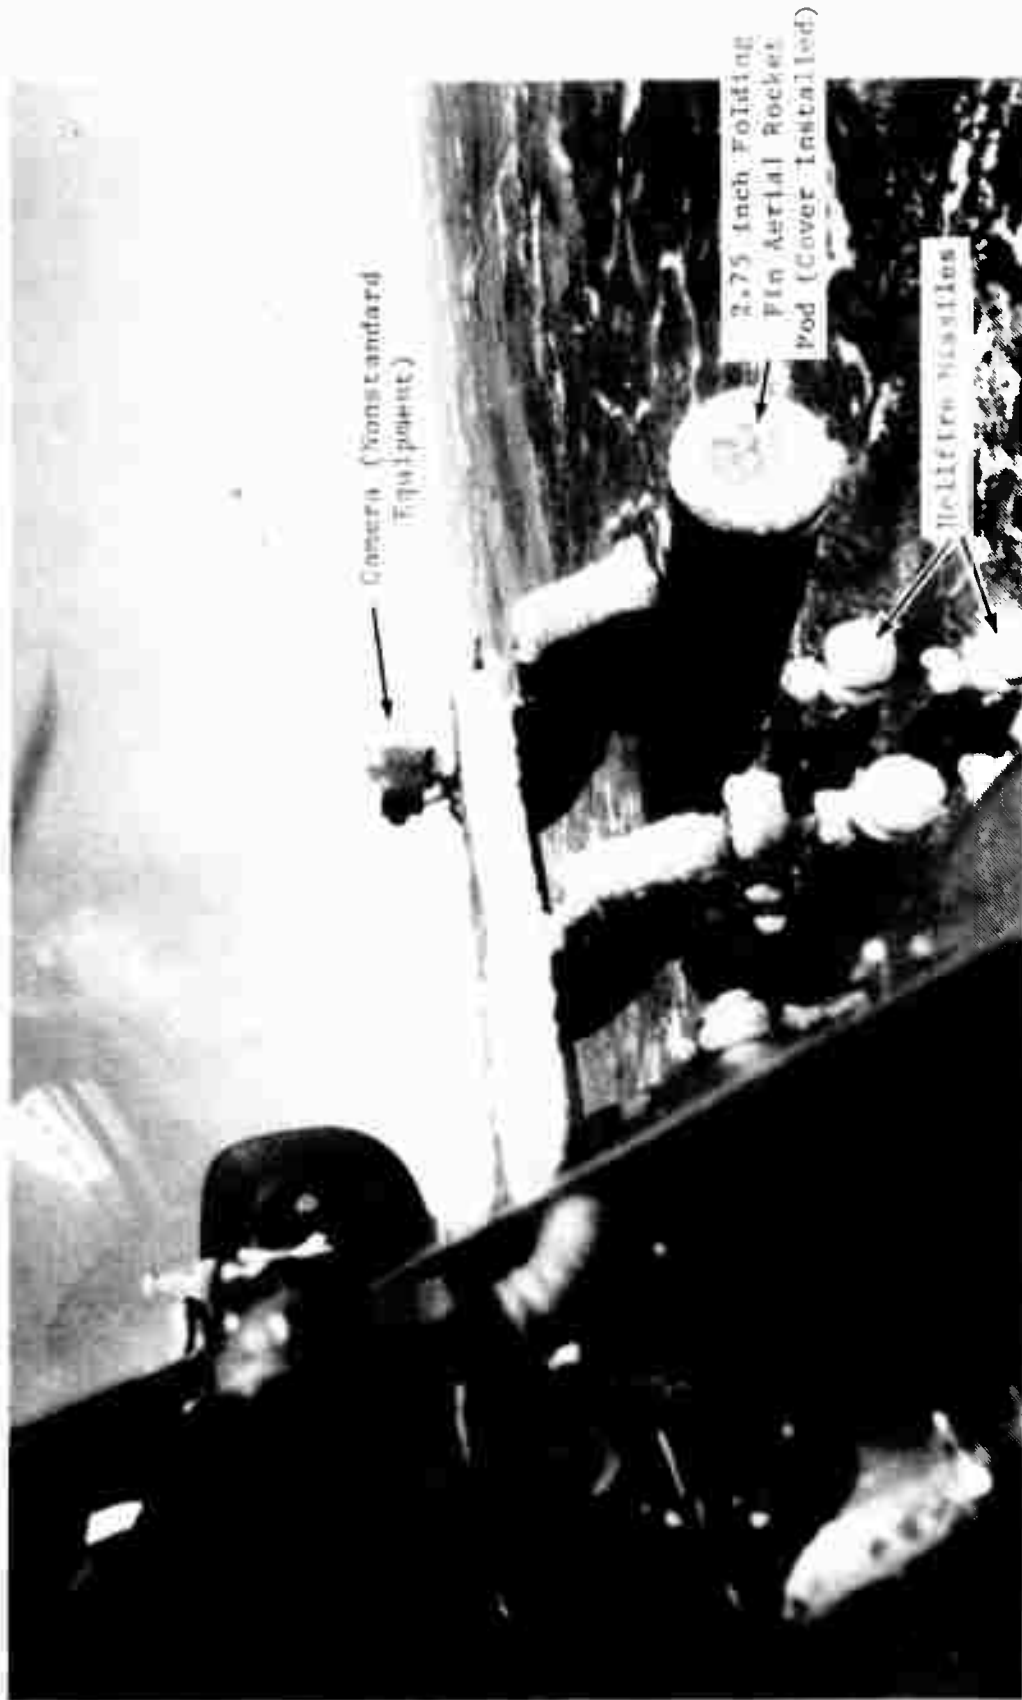
Photo 7. Ice Accumulation on Left Side Wing Stores - Pilot's Station Looking Aft

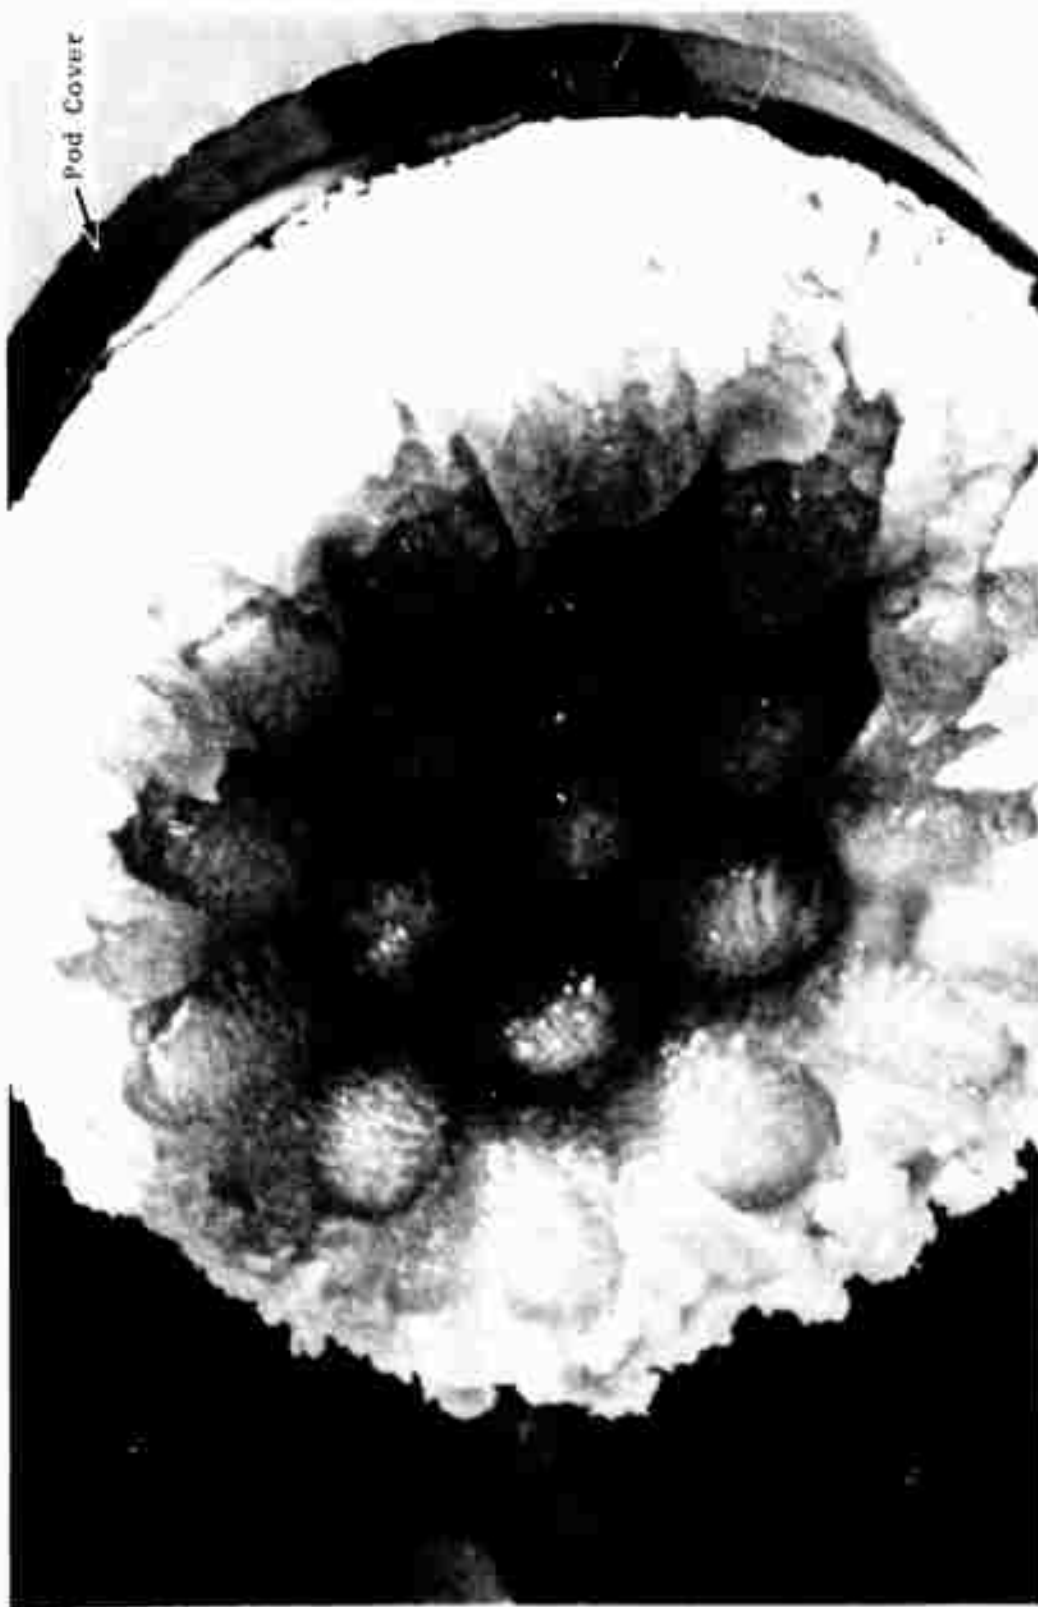
Photo 9. Residual Ice Accumulation on 2.75 inch Folding Fin Aerial Rocket Pod  
With Cover Installed
